Dr. Thomas Beumler
Airbus Deutschland GmbH

Fiber Metal Laminate Structures - from Laboratory to Application Overview and Selected Items

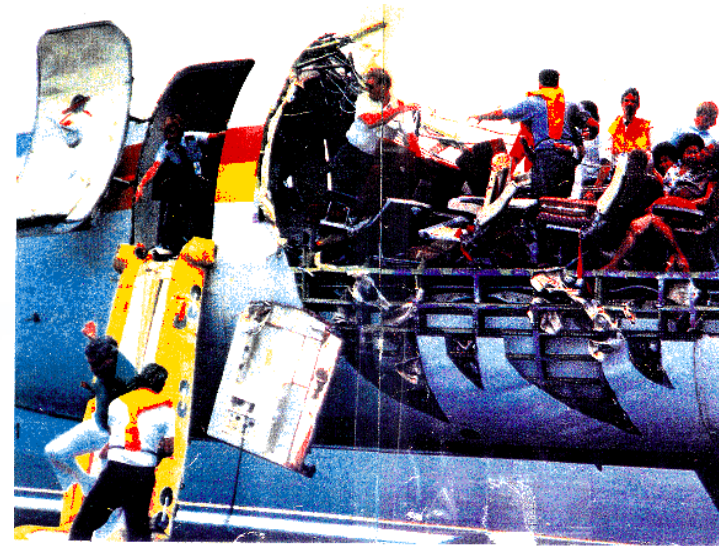
ALOHA incident

- Disbond of longitudinal joint (cold bond film adhesive)
- Aluminium skin stress increased, skin fatigued (MSD) and failed under internal pressure load

- Separation of panels

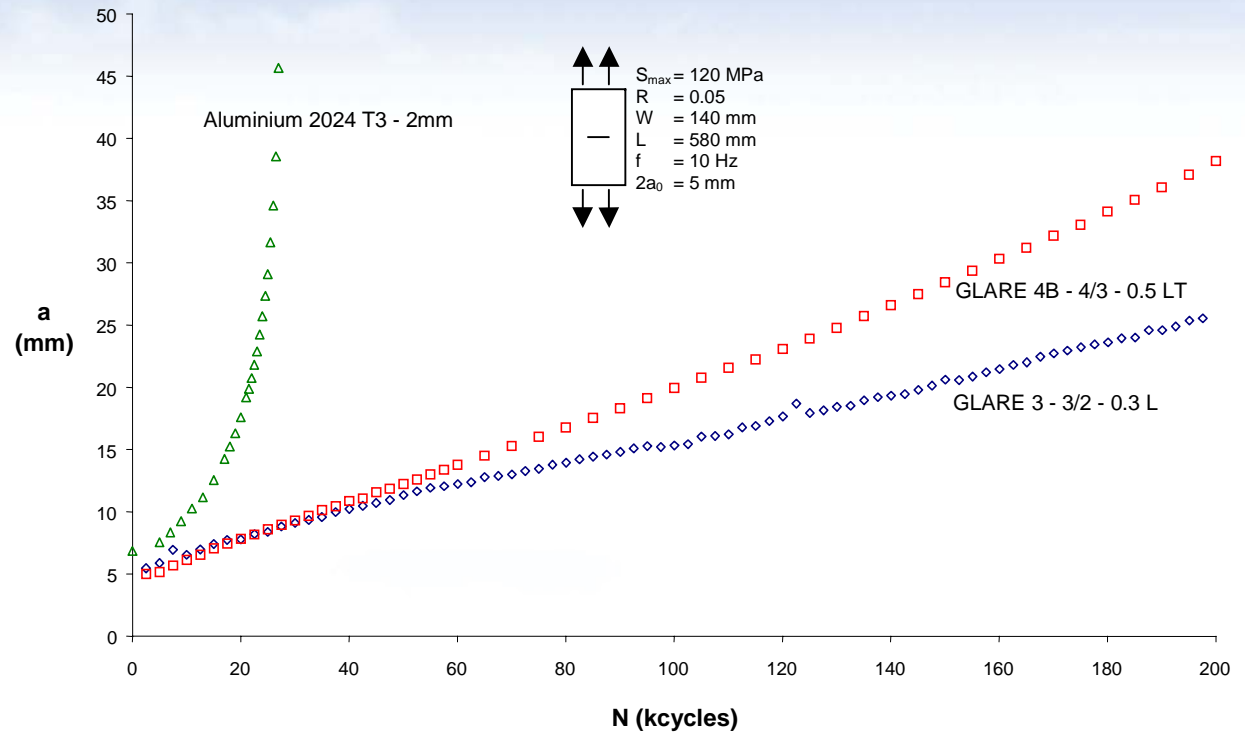
Crack Bridging

- ▶ Fatigue cracks occur in aluminium layers only, starting in outer aluminium layers
- ▶ Fibers stay intact and bridge the fatigue crack

- ▶ Slow crack growth rate and high residual strength compared to aluminium

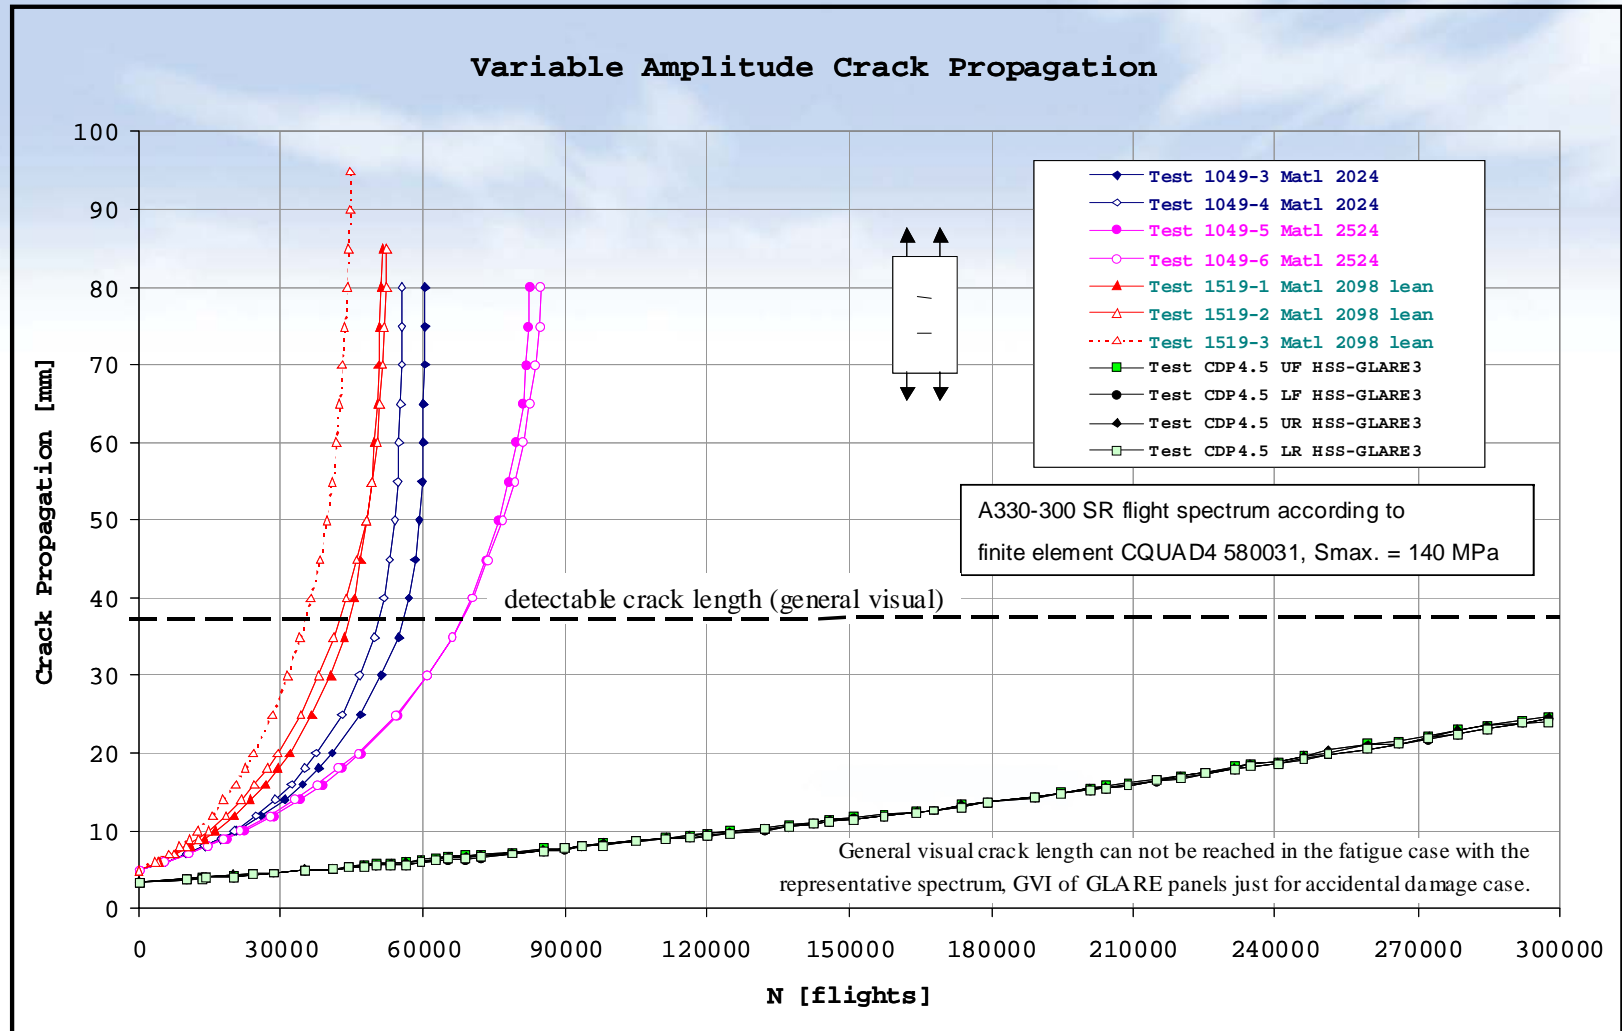
Slow fatigue crack propagation rates

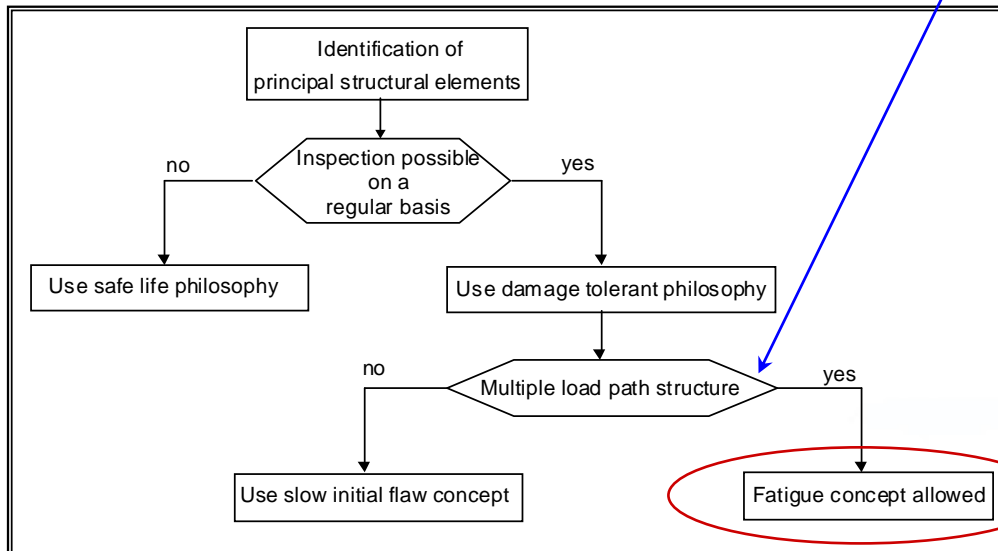
The laminate itself is considered as a second load path material, with the fibers backing up the aluminium.

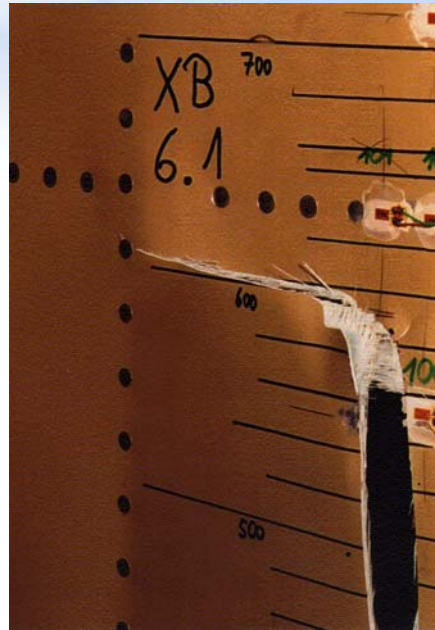
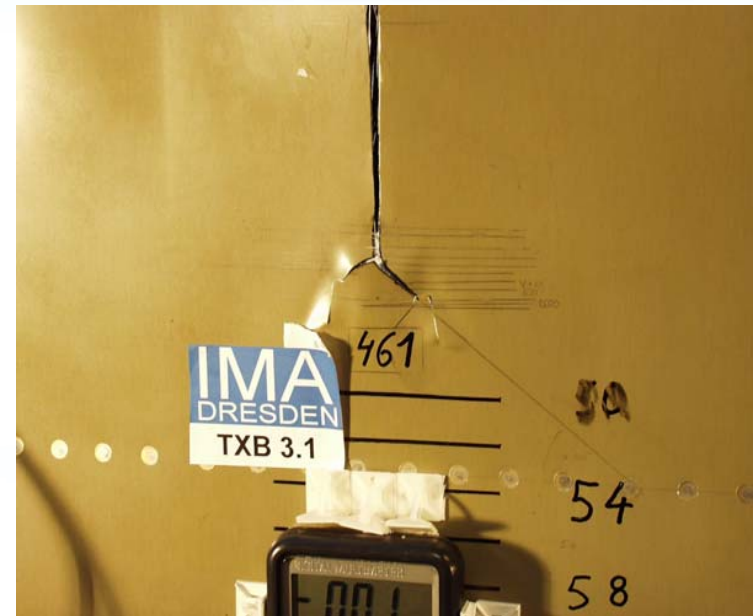
Large Damage Capability of GLARE3improved

Crack turning

Damage stopped
(1170mbar achieved,
685mbar required)

Test performed within TANGO
Program FWP2

→ LDC is no sizing criterion for GLARE3improved

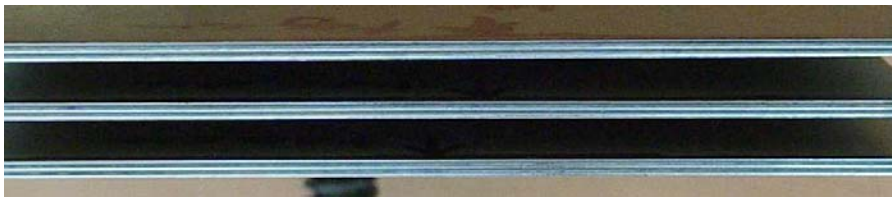
- no delamination of the milled edge
- no large deformation of the material edge
- no fracture of the tool before a milling distance of 25 mtr

Good results

Mill diam. 6 – 8 mm

Speed 8000 rpm

Feed 1200 mm/min

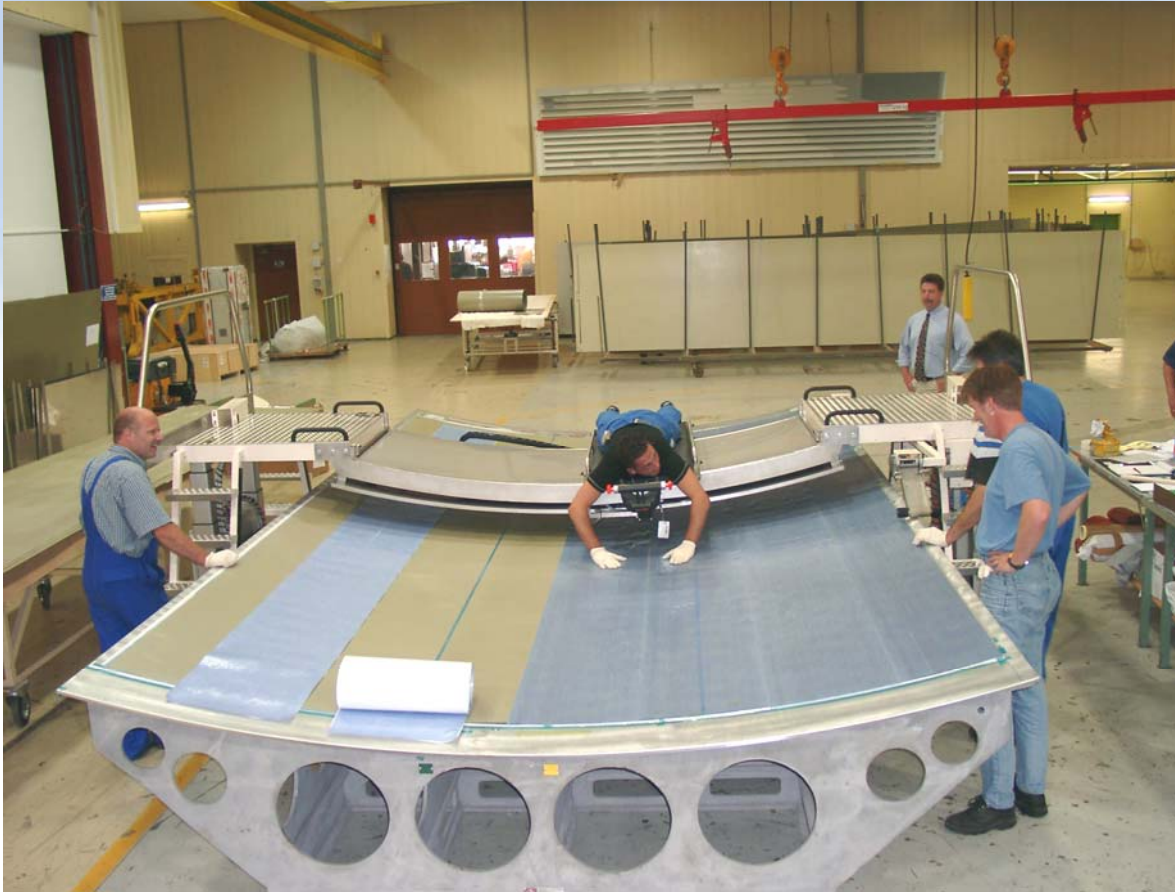
To enable access also to the center of the bond mould, a special portal vehicle has been developed which transports a person over the mould who positions the prepreg and the alu sheets.

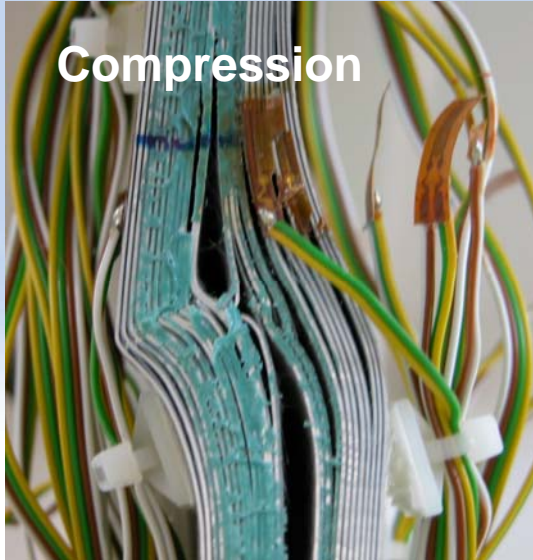
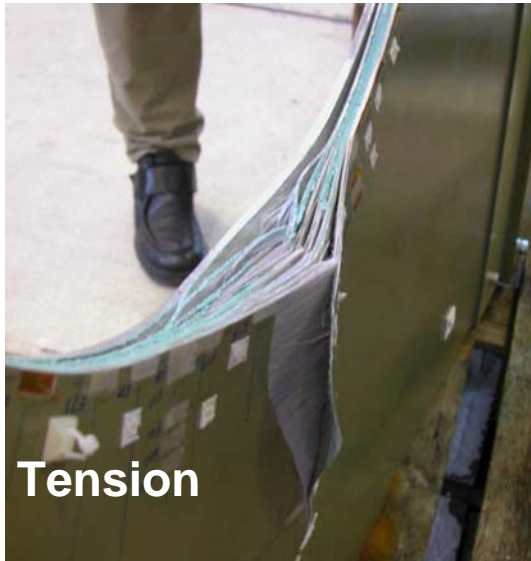
Load reached at failure corresponds to:
A340-200 at MTOW hanging on 440mm wide GLARE door corner specimen

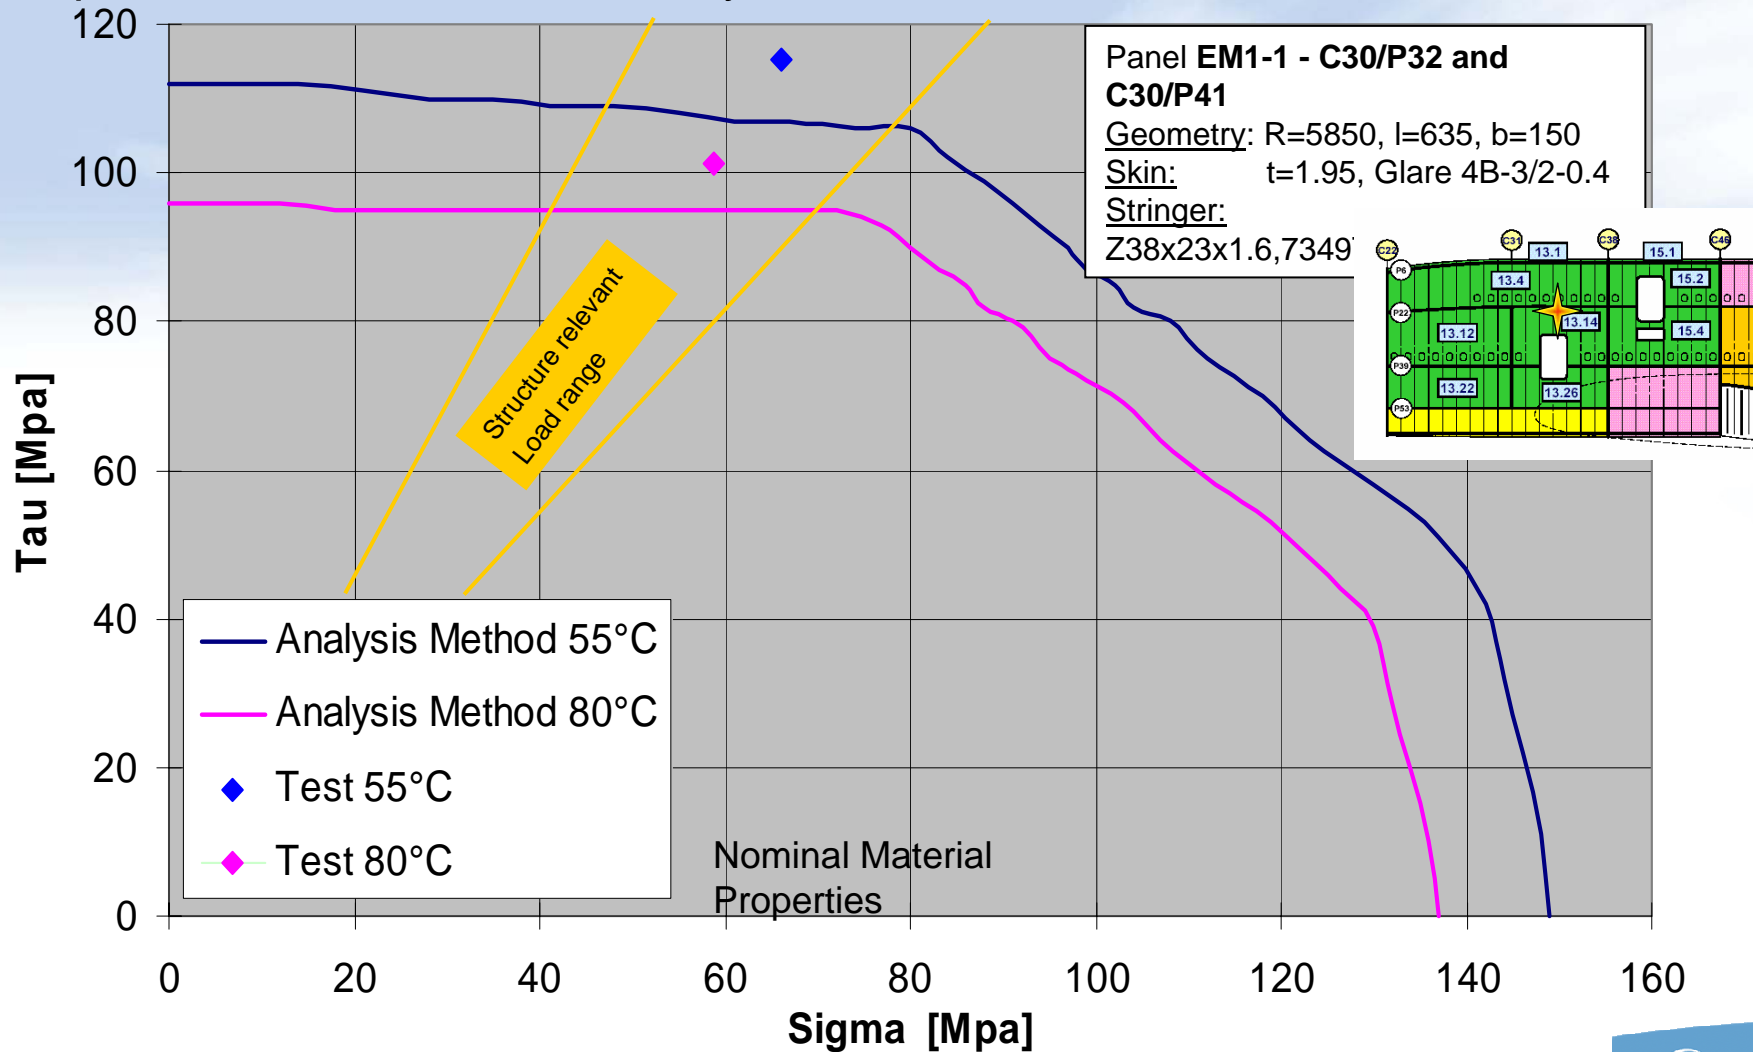
GLARE4B Shell at position C30/P32 and C30/P41 (EM1-1)
 Comparison of test results to analysis method results

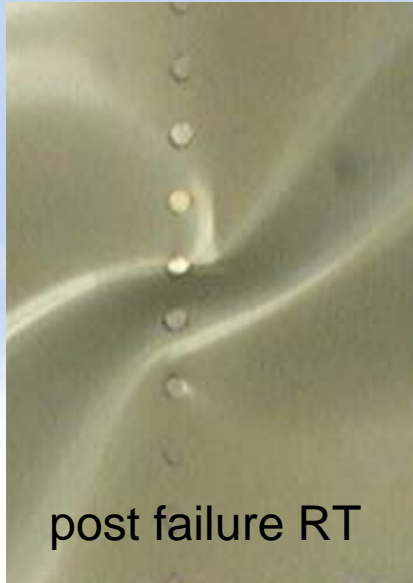
- Panel failure mode in any case: stringer failure
- Secondary failure in case of riveted stringer: interrivet buckling
- Analysis method takes interrivet buckling into account
- Temperature influence on static strength allowables is taken into account by analysis method which is validated by test results

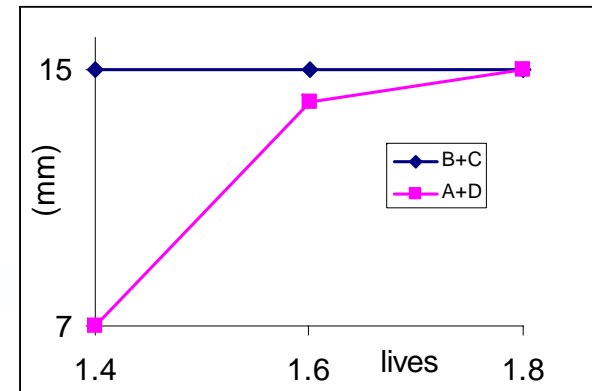
EF, Damages at Riveted Doubler

- Cracks detected after 1.4 DSG
- Cracks stopped propagation after 1.8 DSG

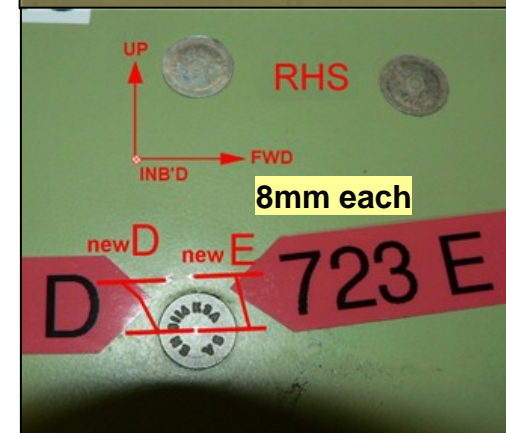
EF, Damages at Stiffness Step

Significant thickness- and stiffness steps in front of rear pressure bulkhead (RPB & section 19 made of CFRP)

Detected at 1.75 DS

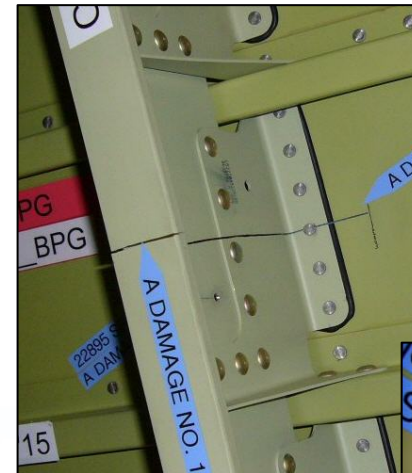
Artificial Dam. No. 910	Title	SF at introduction	Location
	Saw cut in glare skin over a broken frame	22895	C24 P'14 (S13 RH)
